Triggered Surface Slips in Southern California Associated with the 2010 El Mayor-Cucapah, Baja California, Mexico, Earthquake

Open-File Report 2010-1333

Jointly published as California Geological Survey Special Report 221

By Michael J. Rymer, Jerome A. Treiman, Katherine J. Kendrick, James J. Lienkaemper, Ray J. Weldon, Roger Bilham, Meng Wei, Eric J. Fielding, Janis L. Hernandez, Brian P. E. Olson, Pamela J. Irvine, Nichole Knepprath, Robert R. Sickler, Xiaopeng Tong, and Martin E. Siem

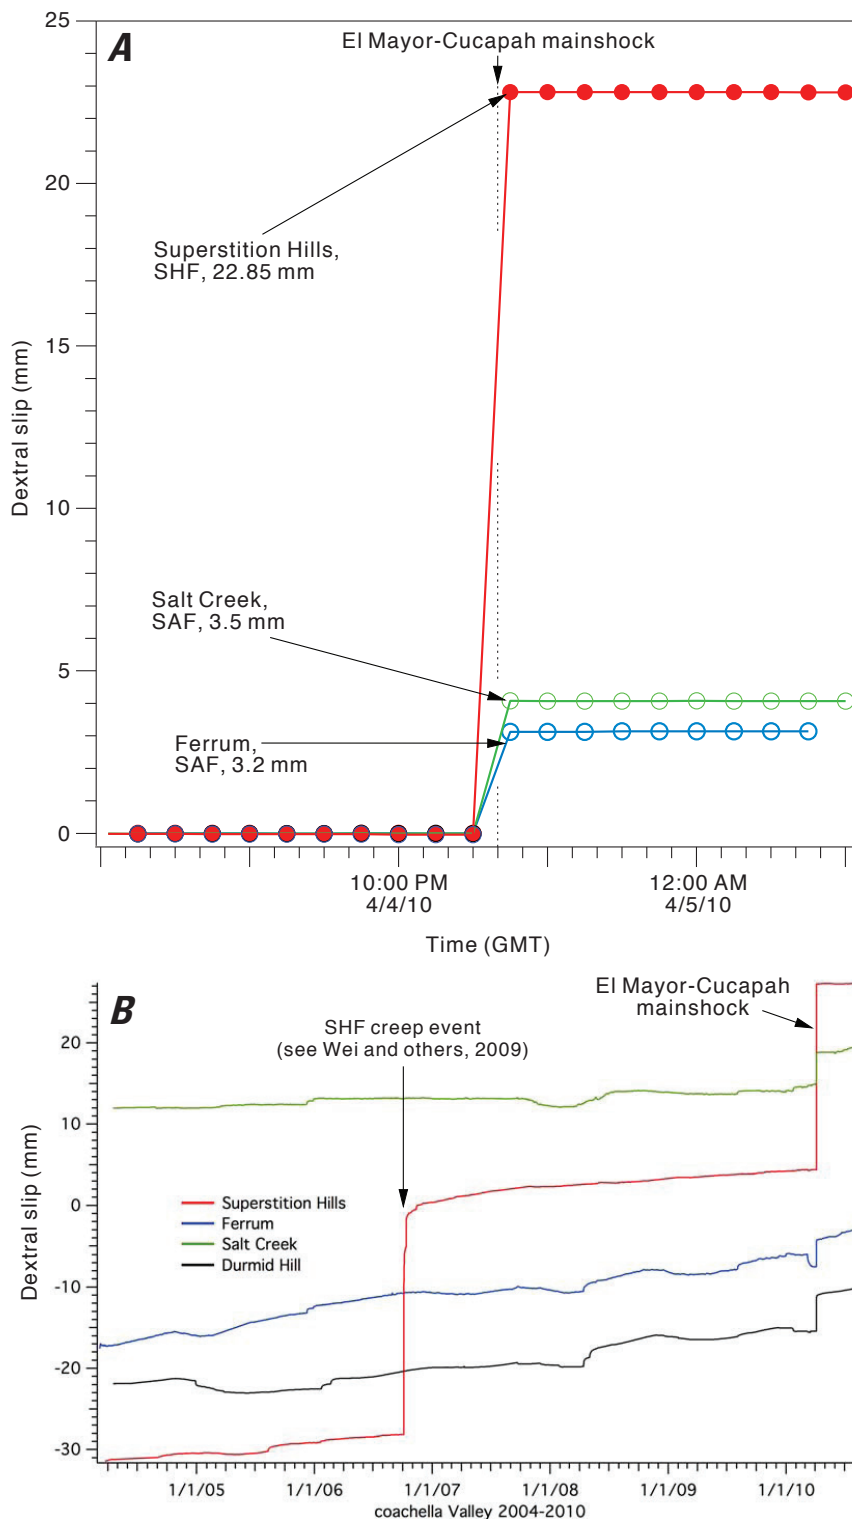
Figure 2. Creepmeter data that show timing of slip on the San Andreas and Superstition Hills Faults in association with the EI Mayor-Cucapah earthquake. *A*, Detailed plot of creepmeter data for three sites in a 6-hr period approximately centered on the EI Mayor-Cucapah earthquake. Data plotted with normalized zero slip before the earthquake. The circles are 10-minute samples. *B*, Plot of a 6-yr period (2004–2010) of creepmeter data. Included in these data is the start of a large creep event on the Superstition Hills Fault (SHF) in October 2006 (see Wei and others, 2009) compared to the abrupt triggered slip recorded on April 4, 2010. Plot shows low background creep rates on fault segments (1–3 mm/yr) interrupted by episodic creep events and triggered slip. Left-lateral excursions (negative slopes) in the data follow rainfall on Durmid Hill. Note that the creep rates on the San Andreas Fault remain high after the EI Mayor-Cucapah earthquake. Transmission problems at both Salt Creek and Ferrum resulted in data gaps following the earthquake that have been interpolated in this plot. The data from Durmid Hill are continuous and confirm the resumption of preseismic creep rates immediately after the triggered slip event. In contrast, the post-earthquake creep rate on the Superstition Hills Fault is slower than the pre-event rate.

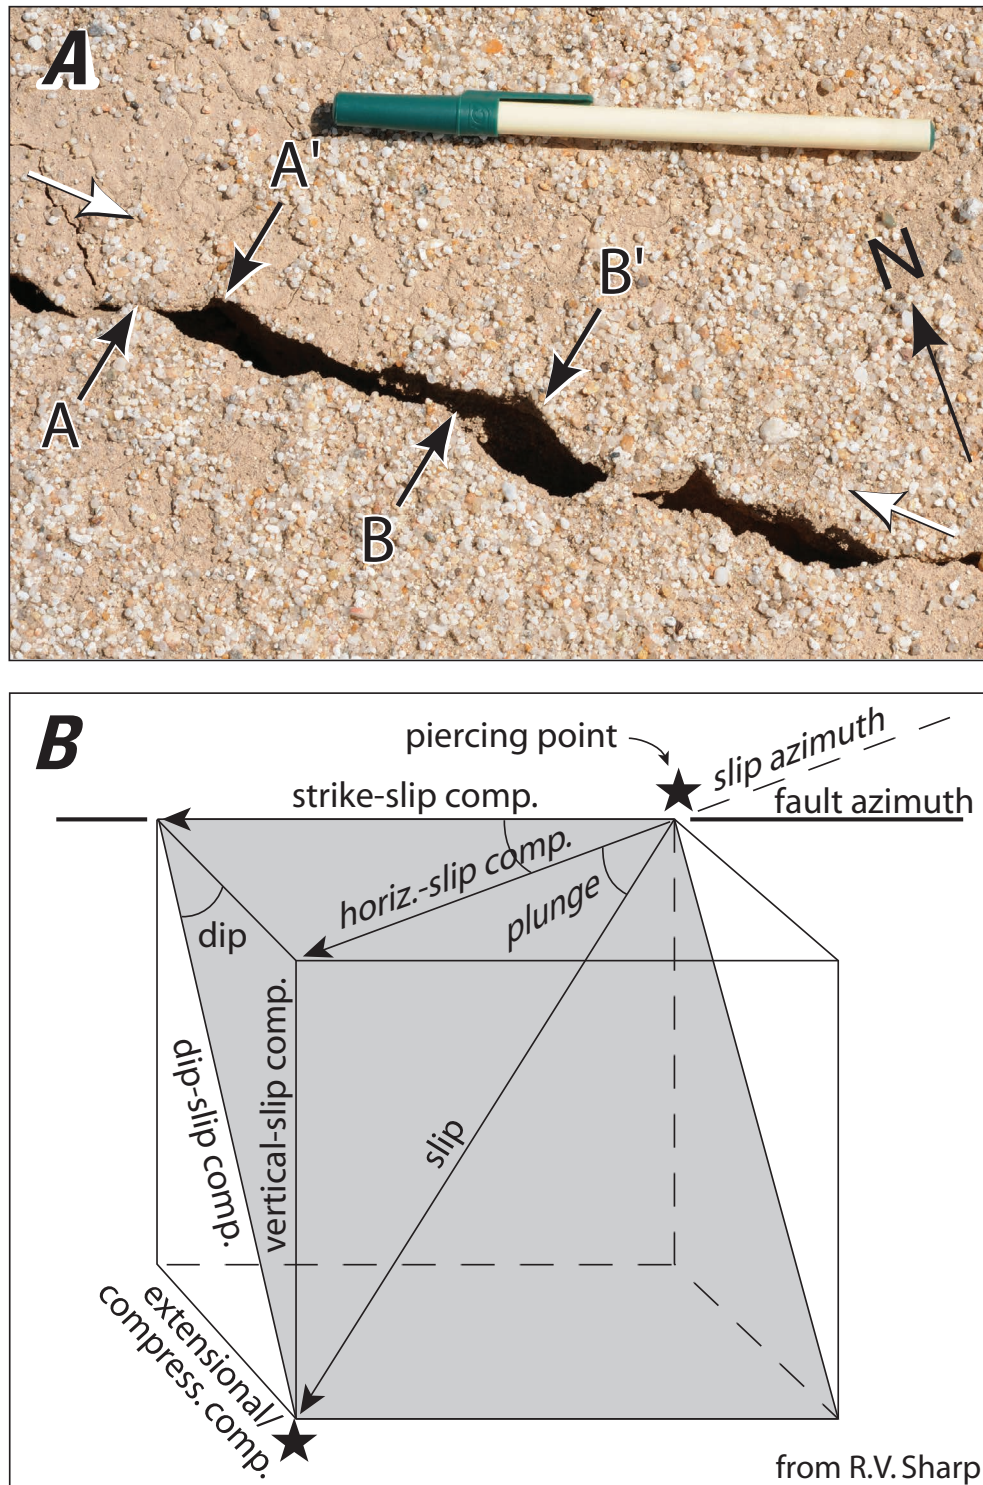
Figure 3. Photograph and diagram showing determination of components of slip. **A**, Photograph of fracture along Laguna Salada Fault, east branch. Corresponding piercing points A and A' and B and B' (black arrows) constrain the calculated amount of right-lateral strike-slip component of displacement (see fig. 25 for location). White arrows, orientation of local fault azimuth. Right-lateral component of displacement at time of photograph was 20 mm; photograph taken April 6, 2010. **B**, Schematic block diagram showing components of fault slip and how to calculate fault parallel component of displacement (see text for explanation).

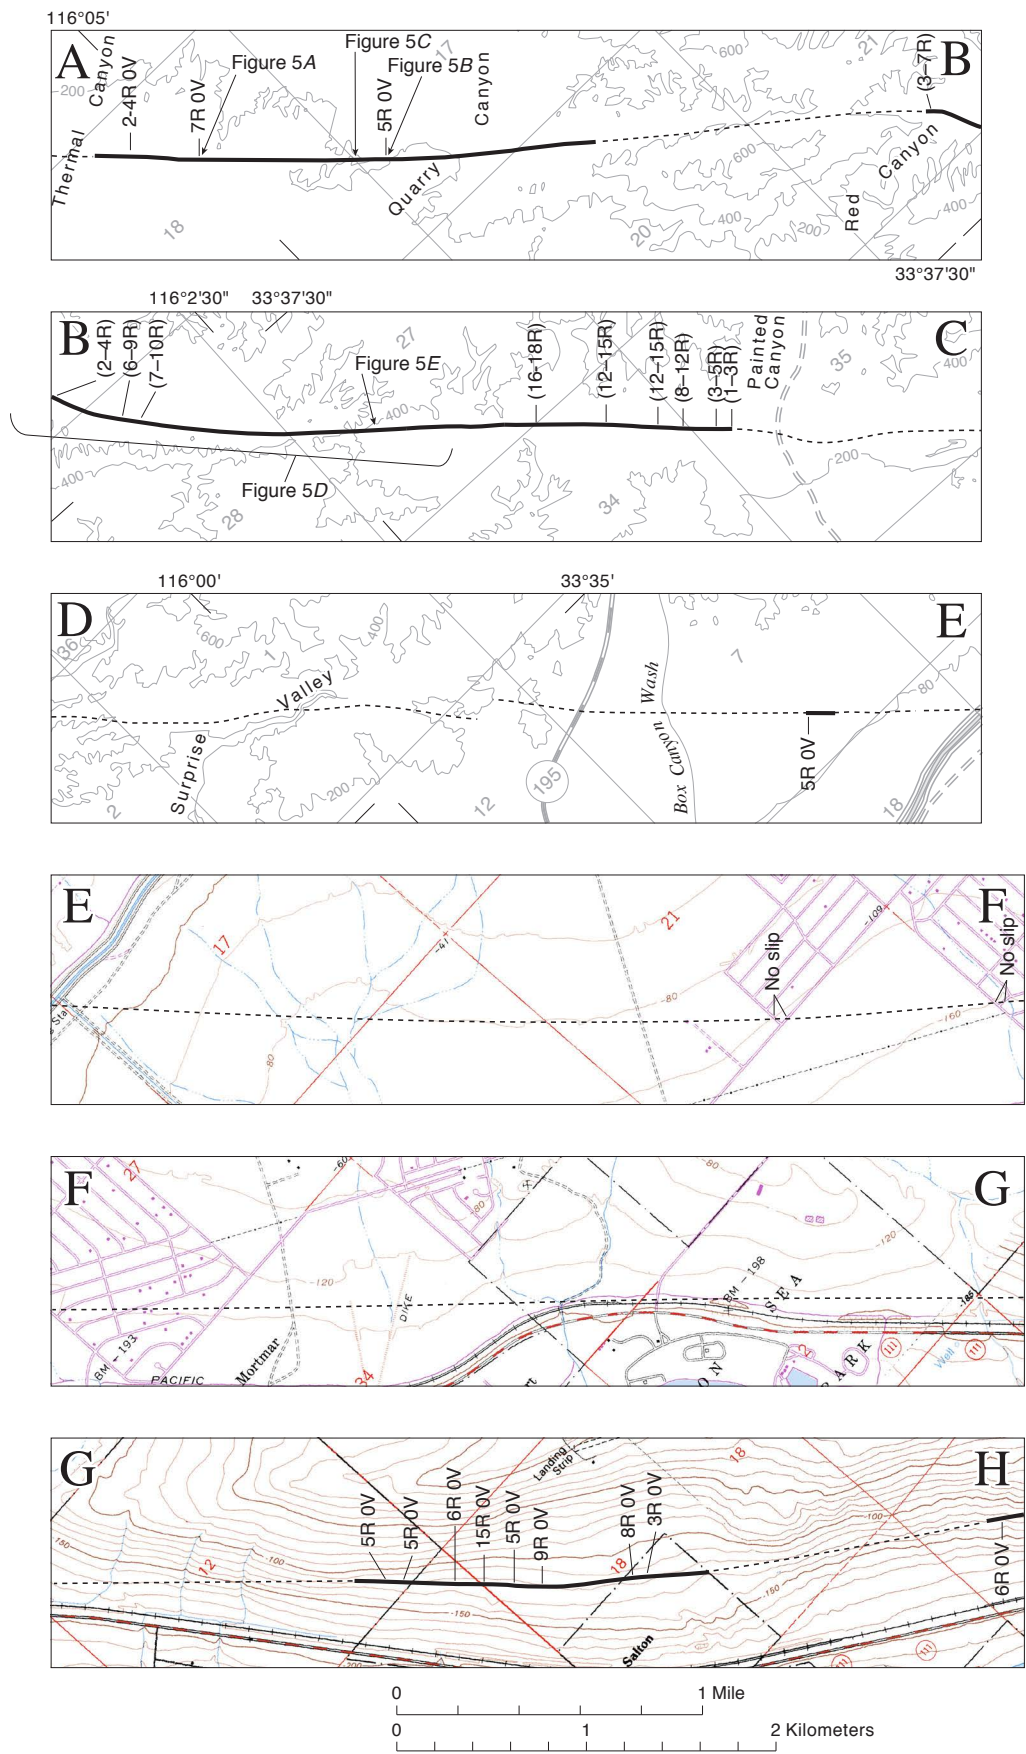
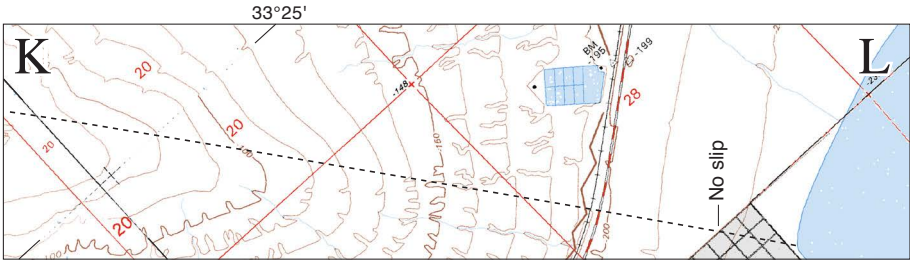
We observed discontinuous surface breaks along the San Andreas Fault over a distance of about 29 km (figs. 1, 4; table 1), spanning distances from the El Mayor-Cucapah epicenter of about 144 and 172 km, from the southeast to the northwest, respectively (table 1). Breaks developed in two broad areas, the Mecca Hills (figs. 5A–C) and between North Shore and Salt Creek (fig. 4, panels A–B, B–C, and G–H). Surface breaks formed predominantly in uplifted Pleistocene fine-grained lacustrine and fluvial deposits.

Figure 4. Strip maps from northwest to southeast (A to L) along the southern San Andreas Fault with location of surface fractures formed in response to 2010 El Mayor-Cucapah earthquake. Dashed line, San Andreas Fault; solid line, location of documented 2010 surface fractures. Amount of slip shown in millimeters for right-lateral (R) and vertical (V) components. Maps derived using selected contours from 1:24,000-scale topographic maps; location of fault from Clark (1984); location of strips shown in figure 1.

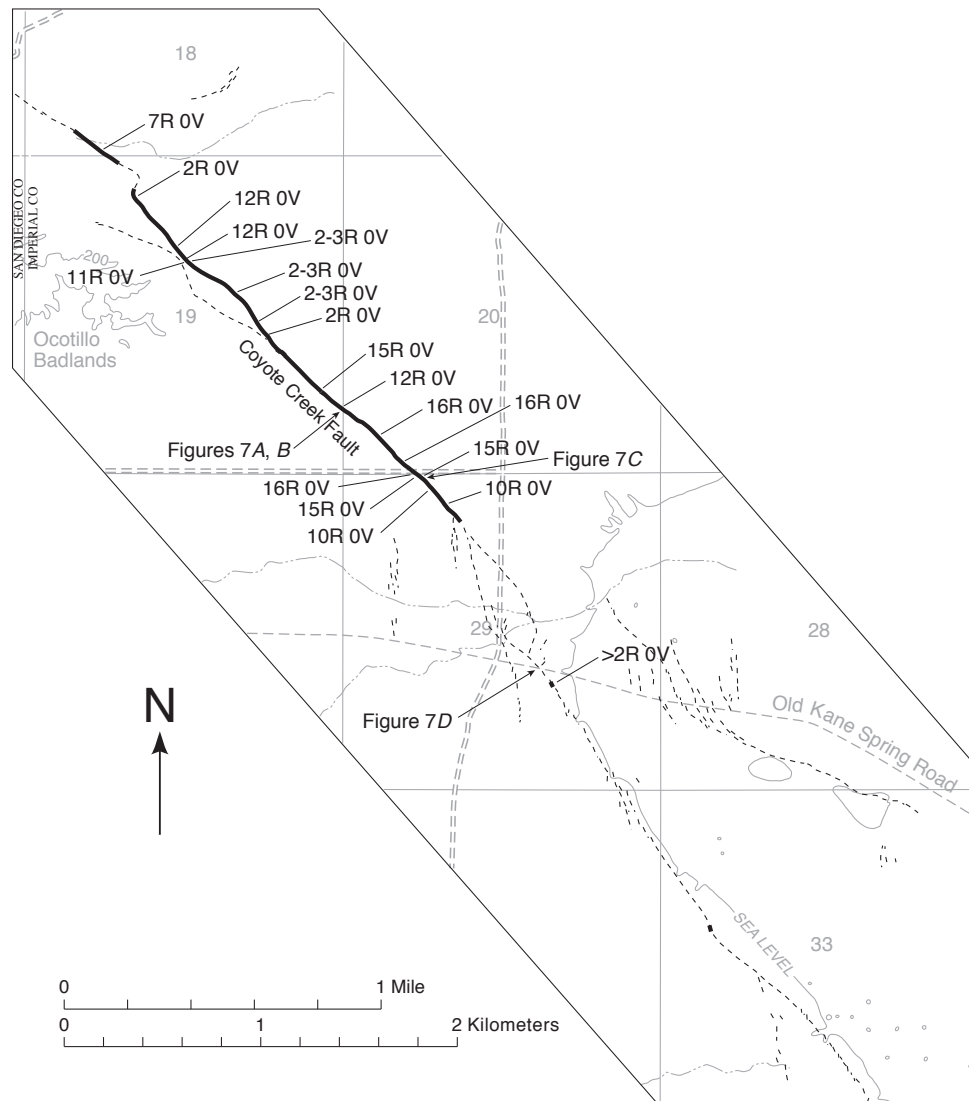
1987; the first of these was primary (coseismic) tectonic slip (Clark, 1972) and the second was slip triggered by the 1987 Superstition Hills earthquake (Hudnut and Clark, 1989). In 2010, discontinuous surface breaks formed along the Coyote Creek Fault over a distance of about 5 km (figs. 1, 6; table 1), at distances of 119–122 km from the El Mayor-Cucapah epicenter (table 1). The distribution and amounts of triggered slip were remarkably similar to those observed by Hudnut and Clark (1989) for the 1987 event. Breaks developed primarily in one broad area, immediately southeast of the Ocotillo Badlands (figs. 6, 7A–C) and in two, short isolated patches to the southeast (fig. 6). Displacements were small. Maximum measured dextral slip was only 16 mm. A feature of interest

Figure 6. Strip map of central part of Coyote Creek Fault showing location of fractures formed in response to 2010 El Mayor-Cucapah earthquake (see fig. 1 for location of map area). Amount of slip shown in millimeters for right-lateral (R) and vertical (V) components. Map derived using selected contours from topographic maps; location of faults from Clark (1972). Map covers same section of Coyote Creek Fault as shown by Hudnut and Clark (1989).

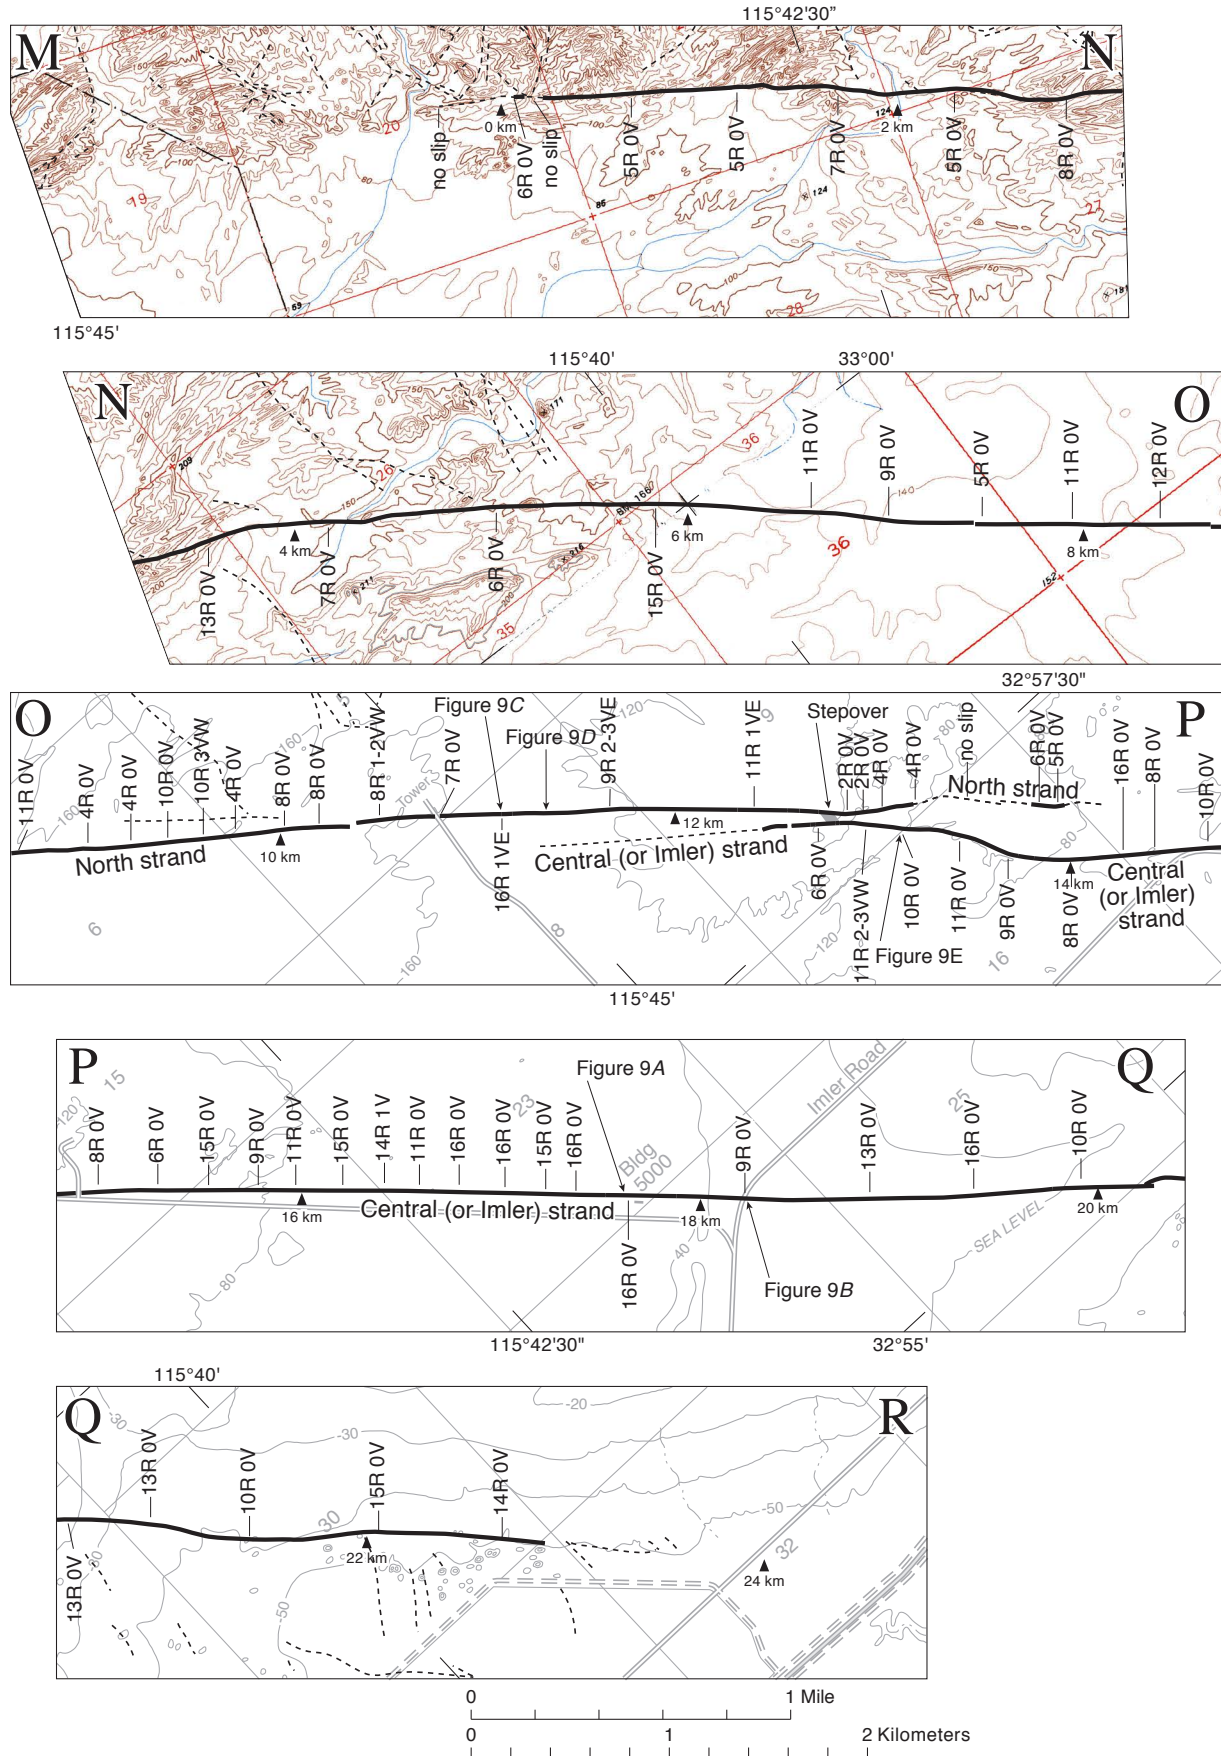
Observed offset was small, less than 16 mm (figs. 8, 9A–C). The amount of dextral slip was largest near the southeastern end of the central or Imler strand (fig. 8). Locally, a small vertical component of slip was measured; nowhere did

◀ **Figure 8.** Strip maps of Superstition Hills Fault with location of surface fractures formed in response to 2010 El Mayor-Cucapah earthquake (see fig. 1 for location of panels M–R). Dotted line, Superstition Hills Fault and related faults; solid line, location of documented 2010 surface fractures. Amount of slip shown in millimeters for both right-lateral (R) and vertical (V) components. Vertical component of slip, where present, is indicated with either west (W) or east (E) side up. Map strips derived using selected contours from topographic maps. Distance scale along fault is the same as used by Sharp and others (1986a, 1989), with reference point located near western end of Superstition Hills Fault.

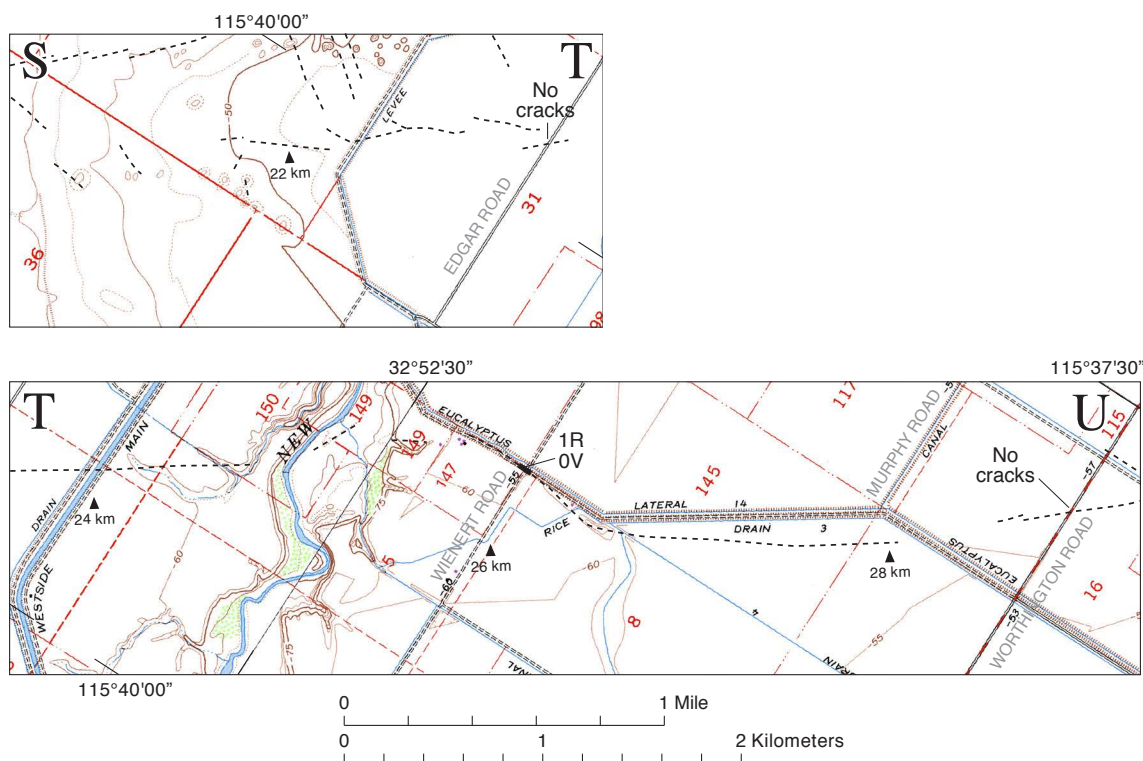
Triggered slip in 2010 along the Wienert Fault in the western Imperial Valley occurred in the same location where the fault had moved tectonically in a previous moderate earthquake, the 1987 Superstition Hills event. We documented left-stepping, en echelon fractures crossing Wienert Road; the fractures extended into adjacent fields, where evidence of fresh fracturing was obscured by abundant desiccation cracks in the soil. We also checked for fresh surface fractures along Edgar Road and Worthington Road, to the northwest and southeast of Wienert Road, respectively (fig 10); however we did not observe fresh surface fractures along these roads.

Figure 10. Strip maps of Wienert Fault (Wienert strand of the Superstition Hills Fault) with location of surface fractures formed in response to 2010 El Mayor-Cucapah earthquake (see fig. 1 for location of panels S–U). Dotted line, Wienert Fault; solid line, location of documented 2010 surface fractures. Amount of slip shown in millimeters for both right-lateral (R) and vertical (V) components. Map strips derived from topographic maps. Distance scale along fault is the same as used by Sharp and others (1989), with reference point located near western end of Superstition Hills Fault.

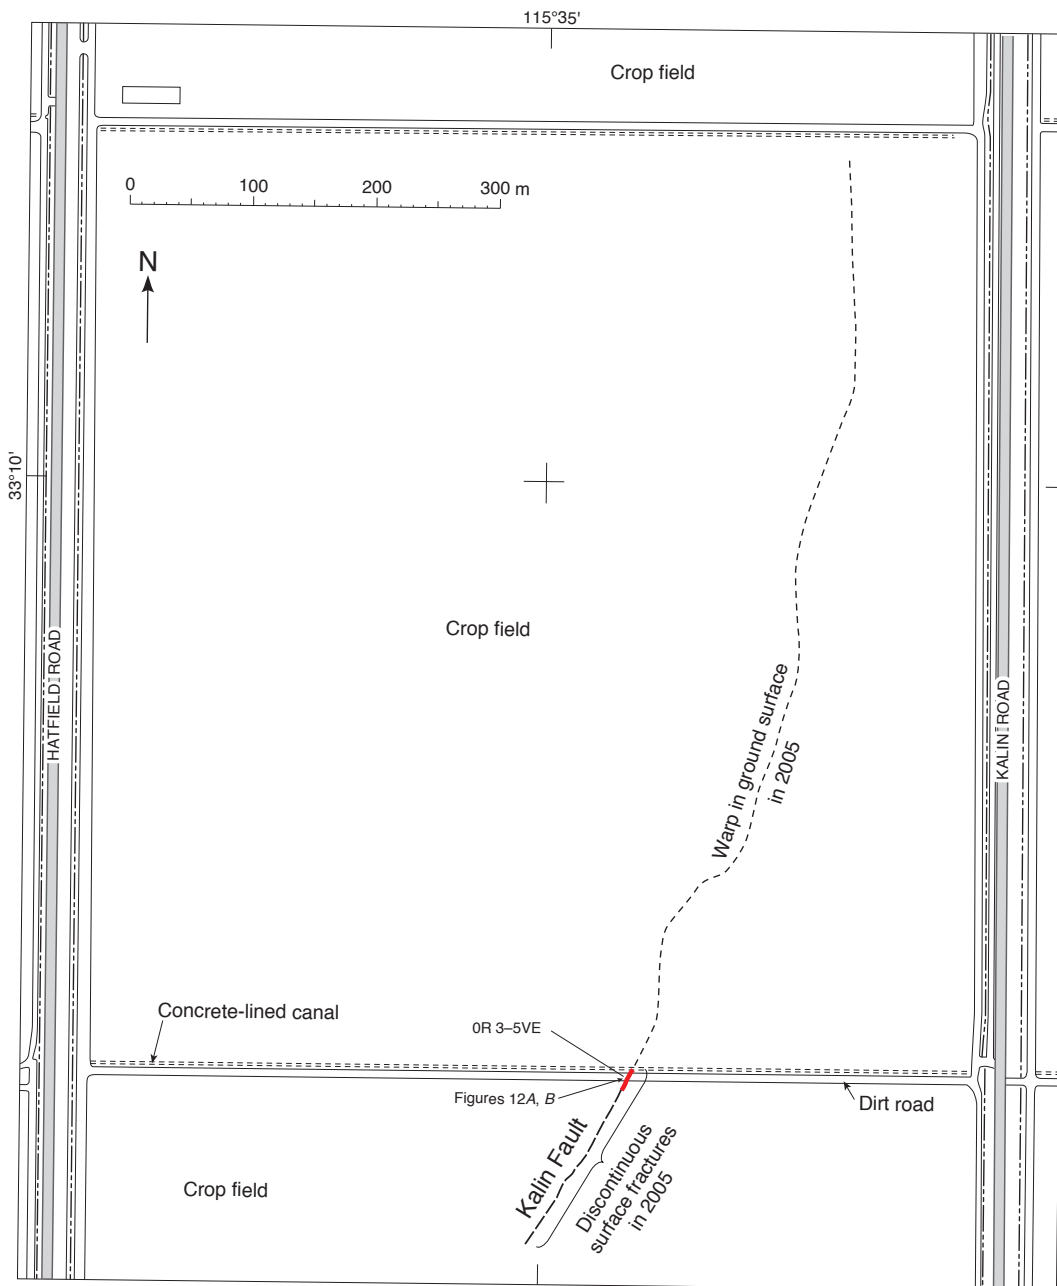
In 2010 we documented discontinuous surface breaks along the Kalin Fault over a distance of about 20 m (figs. 1, 11; table 1), at a distance of about 103 km from the El Mayor-Cucapah epicenter (table 1). Subtle breaks crossed one dirt road and its adjacent shoulder (fig. 11). Surface slip in 2010 likely extended farther, but local, dense vegetation (see upper part of fig 12*B*) prevented our observing the fresh fractures in the fields. Amounts of displacement were small; maximum measured vertical slip was only 3–5 mm, east side up. We did not see renewed breakage of the nearby concrete-lined canal, which had broken during the 2005 earthquake swarm.

High-resolution shallow seismic imaging across the Kalin Fault, both along the dirt road where fractures developed in 2005 and 2010 and along the dirt road near the top of figure 11, delineate a structurally complex fault in the subsurface. In the shallow subsurface (upper 200 m) along the more southerly of these two roads, Rymer and others (2009) interpret a narrow (10- to 30-m-wide) zone of faults that dips about 70 degrees to the northwest. Below 200 m depth the fault zone is nearly vertical, has a width of about 200 m, and consists of at least four anastomosing strands.

Figure 11. Map of Kalin Fault with location of surface fractures formed in association with 2010 El Mayor-Cucapah earthquake (see fig. 1 for location of map).

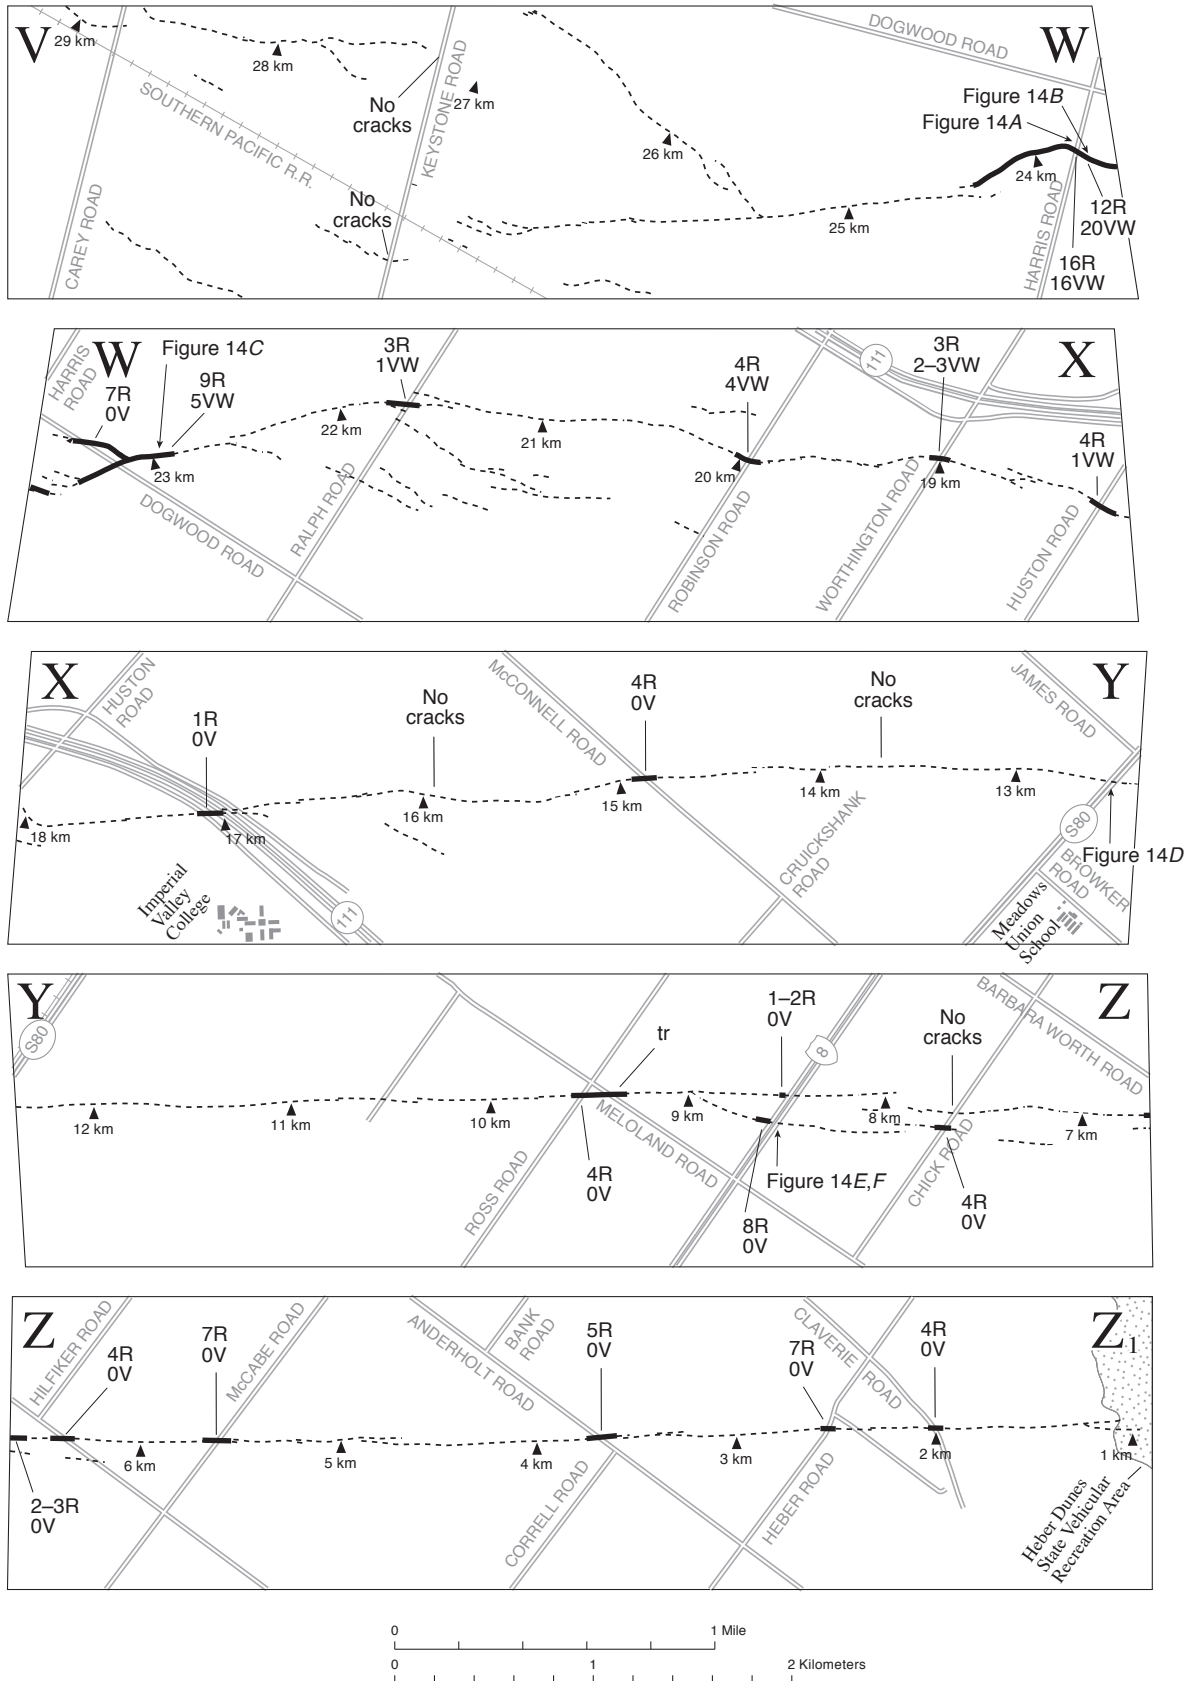
Discontinuous surface breaks formed along the Imperial Fault over a distance of about 22 km (figs. 13, 14; table 1), at distances of about 52 and 73 km from the El Mayor-Cucapah epicenter to the northwest and southeast endpoints of the triggered slip, respectively (table 1). Two factors limited the continuity and extent of our mapping of surface breakage. Cultivated fields, especially fields with dense crops, were not checked for surface fractures. Some fields recently had been cleared of crops, and these were checked for surface breaks. Generally this was a futile effort because locally abundant desiccation cracks masked the presence of small slip displacements. The 2010 triggered slip likely extended farther north than Harris Road. No slip was observed at Keystone Road, and thus, the northern end of 2010 triggered slip lies somewhere between Harris and Keystone Roads, north of our measurement sites (fig. 13, panel V–W).

Offset values were small, dextral slip being less than 16 mm (figs. 13, 14*B*). Dextral slip was greatest near the northern end of triggered surface breakage (fig. 13). Locally there was a minor 1–5 mm vertical component of slip; larger amounts of vertical slip (as much as 20 mm) occurred in Mesquite basin (near kilometers 23–24, fig. 13), where fault scarps indicate oblique slip for this part of the Imperial Fault (fig. 14*A*).

Figure 13. Strip maps of Imperial Fault with location of surface fractures formed in response to 2010 El Mayor-Cucapah earthquake (see fig. 1 for location of panels V–Z₁). Dotted line, Imperial Fault; solid line, location of documented 2010 surface fractures. Amount of slip shown in millimeters for both right-lateral (R) and vertical (V) components. Vertical component of slip, where present, is indicated with either west (W) or east (E) side up. Map strips depict local roads from 7 1/2-minute topographic maps. Distance scale along fault is the same as used by Sharp and others (1982), with reference point located near southern end of Imperial Fault.

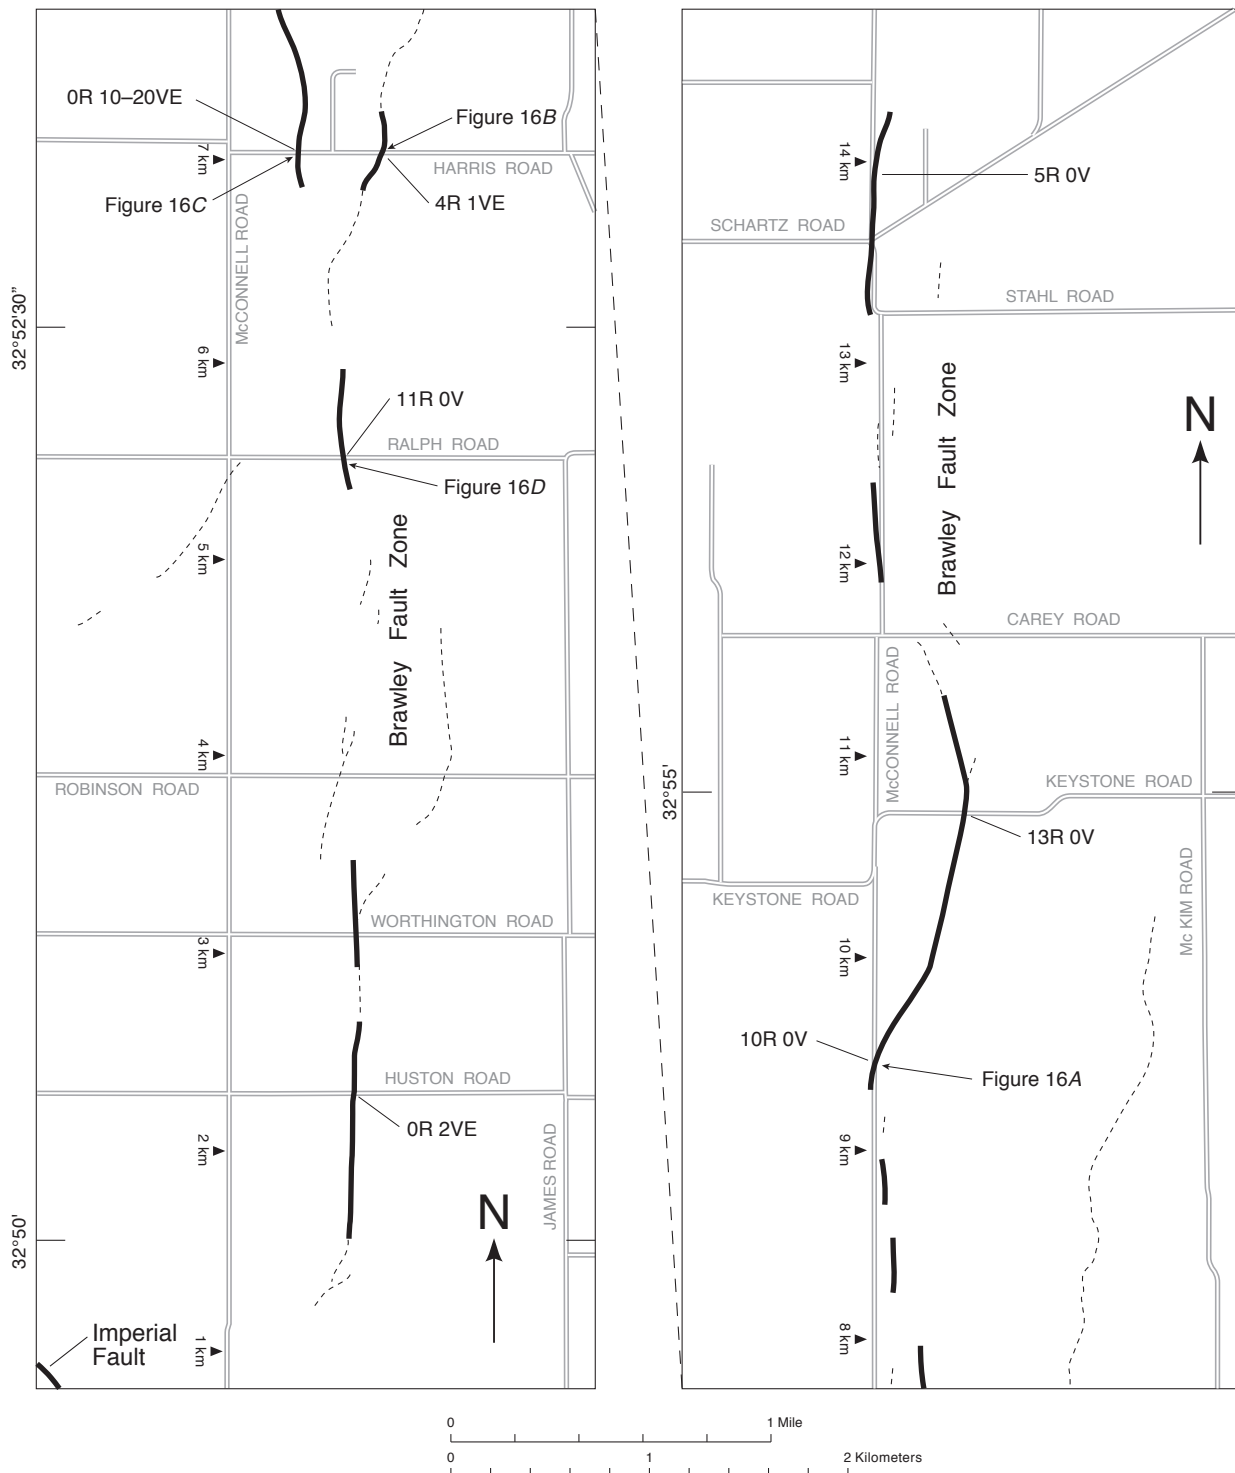
Figure 15. Strip maps of Brawley Fault Zone with location of surface fractures formed in response to 2010 El Mayor-Cucapah earthquake (see fig. 1 for location of map strips). Dotted line, Brawley Fault Zone; solid line, location of documented 2010 surface fractures. Amount of slip shown in millimeters for both right-lateral (R) and vertical (V) components. Vertical component of slip, where present, indicated with either west (W) or east (E) side up. Map strips depict local roads from Holtville West and Alamo 7 1/2-minute topographic maps. Distance scale along fault is the same as used by Sharp and others (1982), with reference point located near southern end of Imperial Fault.

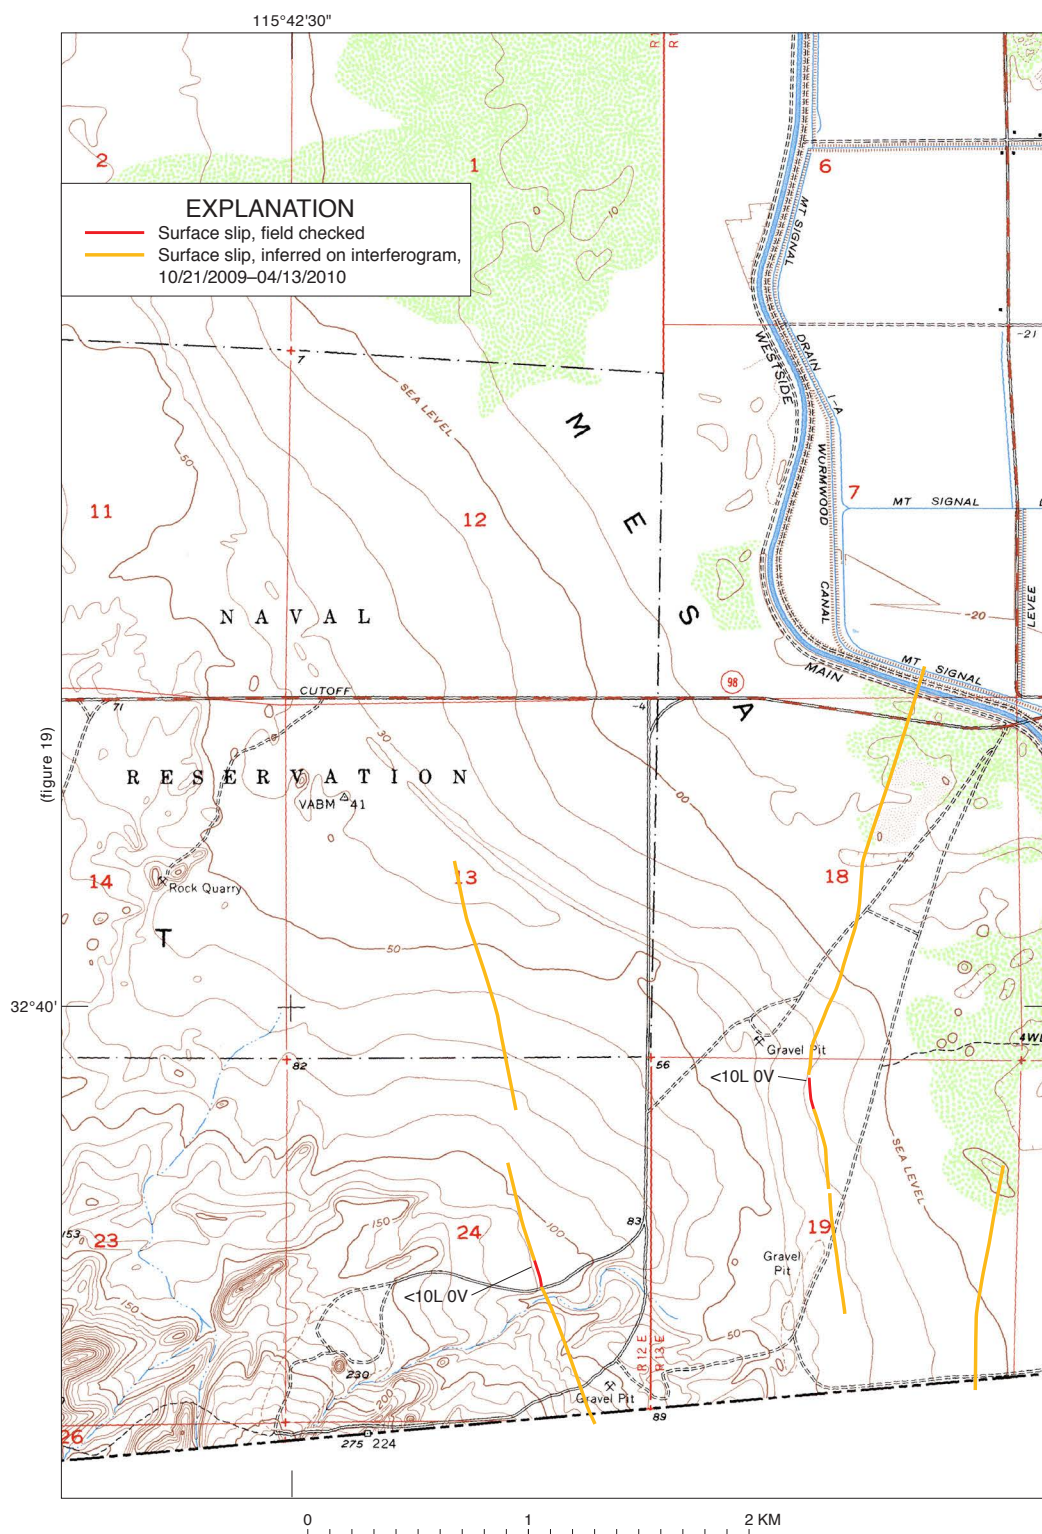
Figure 18. Map of faults and surface fractures in easternmost Yuha Desert. Faults shown are part of the Northern Centinela Fault Zone. Amount of slip shown in millimeters for both left-lateral (L) and vertical (V) components. Map base from a portion of the Mount Signal 7 1/2-minute topographic quadrangle. See figure 17 for location of map area.

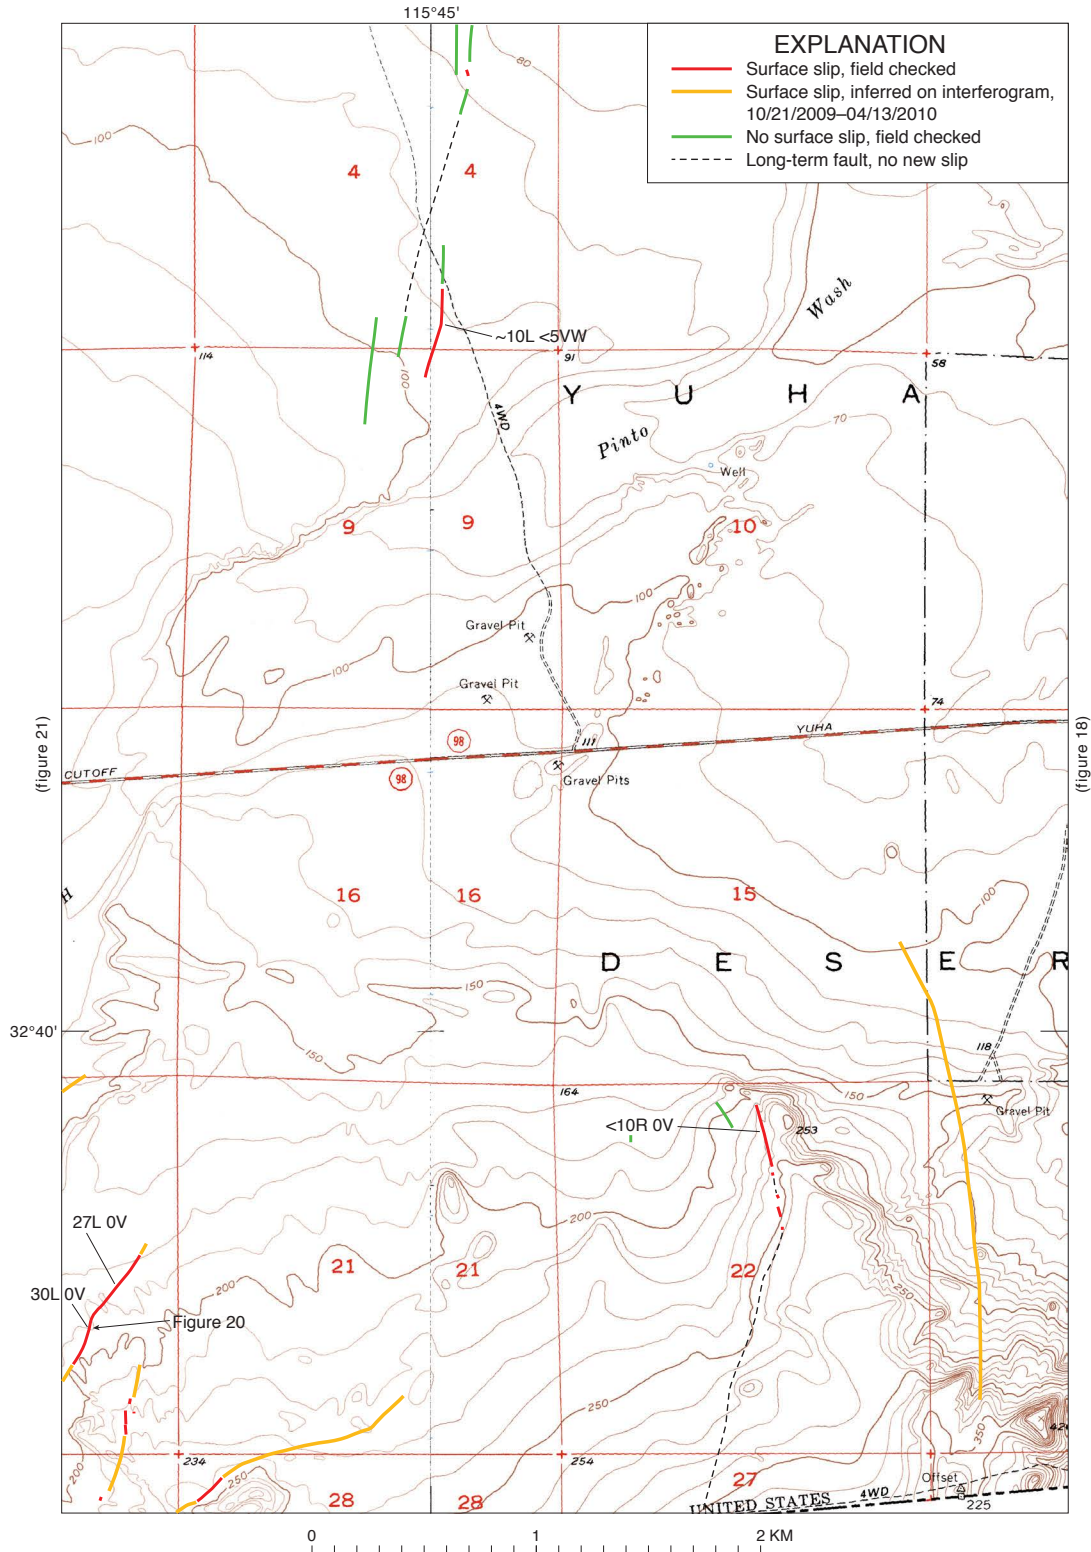
Field checks for surface breakage in the Northern Centinela Fault Zone (figs. 17–19) began on May 12, 2010, 38 days after the El Mayor-Cucapah earthquake. One of us (J.A.T.) checked the Northern Centinela Fault Zone in its westernmost extent (figs. 17, 19) and found minor, fresh surface slip. Additional field checks were made on June 19, 2010, in the broader fault zone (J.A.T.) based on dislocations on interferograms. In this latter field venture we checked and verified surface slip along additional faults within the Northern Centinela Fault Zone (fig. 18). Unfortunately, some recent surface slip likely had already been obscured by active aeolian sand deposition since the earthquake.

fig. 19), which has an obvious fault scarp that extends at least 3.4 km south of the U.S.-Mexico border. More prominent surface slip is reported south of the border (Sinan Akciz, written commun., 2010, 2011; Fletcher and others, 2010).

Figure 19. Map of faults and surface fractures in eastern Yuha Desert. Faults shown include elements of the Northern Centinela Fault Zone (Sections 14 and 15, 22 and 23), Yuha Fault (sections 4 and 9) and faults south of Pinto Wash (Section 20, 21, 28, and 29). Amount of slip shown in millimeters for both right-lateral (R), or left-lateral (L), and vertical (V) components. Vertical component of slip, where present, is indicated with either west (W) or east (E) side up. Map base from portions of the Mount Signal and Yuha Basin 7 1/2-minute topographic quadrangles. See figure 17 for location of map area.
